# Network hub failure

## Application Note

### Power Quality Case Study

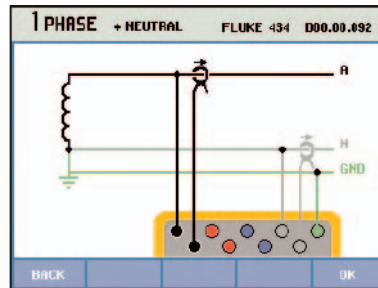
Fig. 1 View configuration screen

After connecting his Fluke 434 to the branch circuit supplying the hub equipment, he checked the View Config screen (Fig. 1) diagram to verify proper connections. From there, he pushed the Scope button and saw an abnormally high neutral waveform. (Fig. 2) He checked the numeric values at the top of the screen and saw that neutral voltage was in fact incredibly high, at 23 volts, indicating a possible neutral-ground issue. He saved that screen for customer documentation.

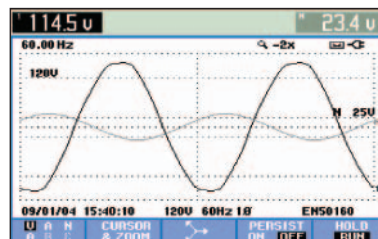
Fig. 2 High neutral waveform

He traced the branch circuit to the isolated ground receptacle but couldn't find a grounding conductor. That was a little too isolated! Not having a grounding conductor caused an open ground condition. That was not only a problem for the electronic equipment, but also a safety hazard to personnel and equipment. As a temporary fix, he recommended replacing the isolated ground receptacle with a legal, standard receptacle. The standard receptacle would allow the client to use conduit as the standard equipment grounding providing proper grounding for the branch circuit.

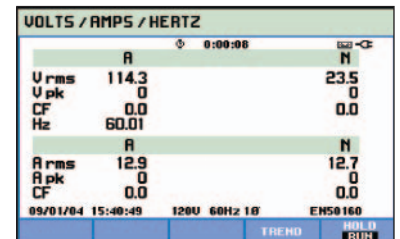
Fig. 3 Voltage level check

Just to be sure, he switched to the V-A-Hz screen (Fig. 3) and checked the voltage level again. He got the same results. Following standard power quality practices, he began looking for a grounding problem at the branch circuit, since that was the next step in the wiring path.

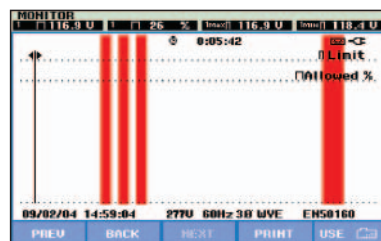
Fig. 4 Set recording time

He pressed the Monitor button (Fig. 4) and set the recording time for 24 hours. After the first 15 minutes, he pushed the trend button while continuing to record in the background. (Fig. 5) Shortly into the cycle he saw a dip in the line.

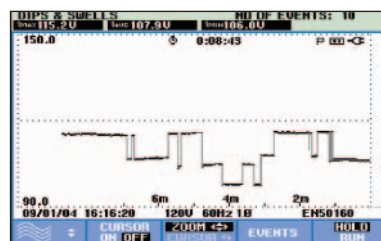
Fig. 5 Dip swells

The panel was clearly carrying too much load, most likely from one or more of the facility's large motors. That meant the hub was seeing high voltage from the grounding problem and low voltage from the sags, both of which were causing the hub to go down.

Due to the cost and time required to install a new receptacle on the branch circuit, the facility decided to add a UPS in front of the power supply to the hub. Since the remaining equipment on that line wasn't disrupted by the sags, no further actions were required. The consultant downloaded a report of the benchmark power quality measurements he'd made and gave it to the facility, who agreed to set up a regular preventive maintenance schedule.
