Detecting problems in buildings using infrared cameras

Application Note

Testing Functions Case Study

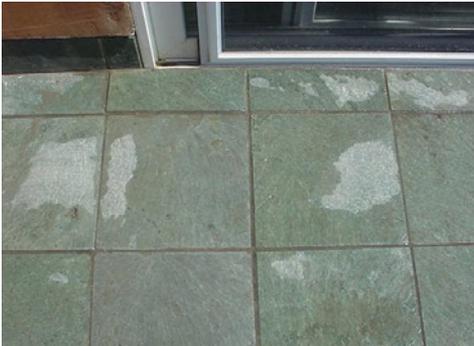
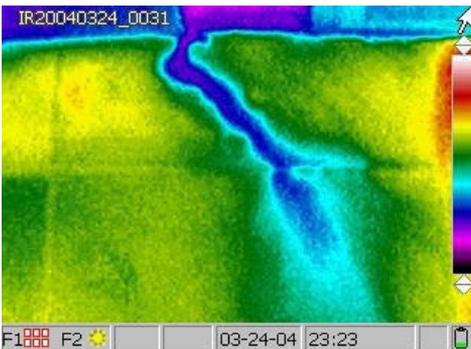
Water running underneath the tile deck into the unit below.

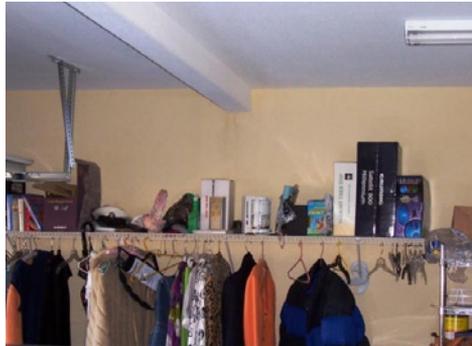
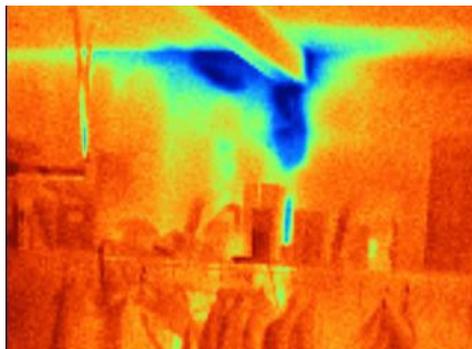
Moisture in drywall is not visible (top) without the use of a thermal imager (bottom).

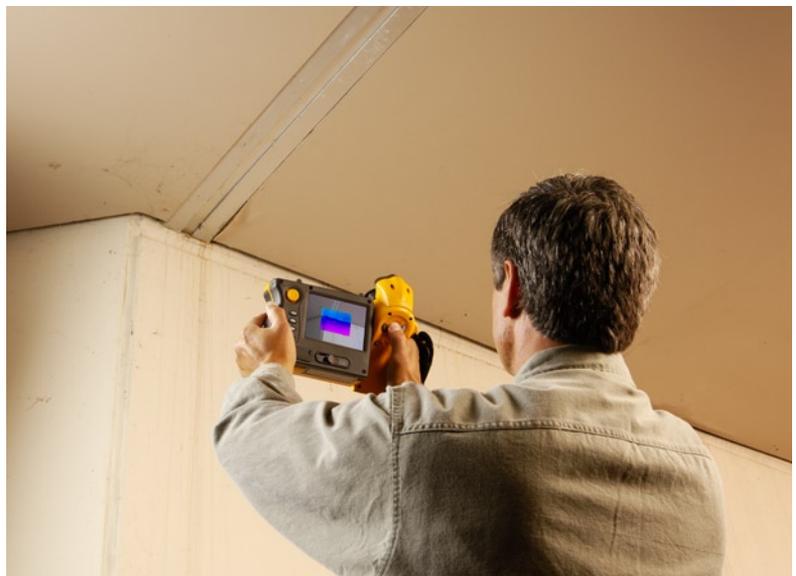
When inspecting for exterior moisture infiltration from windows, siding or other exterior components, it can take an hour or longer after wetting for a thermal pattern to become apparent on the interior. In one example, the point of intrusion was believed to be above a living room window. The exterior wall was soaked with a sprayer per the ASTM standard. After 20 minutes there was no sign of water intrusion on the interior wall or floor. The wall was soaked again for an additional 10 minutes and still there was no thermal pattern evident. It wasn't until nearly an hour after the initial spray test that the thermal pattern from the wet stucco and insulation was visible. Although the moisture penetrated the stucco within

minutes after the first spray test, it took almost an hour for the cooler evaporative temperatures to reach the surface of the interior wall.
